134 Pearson Avenue, Toronto, Ontario

SUMMARY INSPECTION REPORT

INSPECTION REPORT

PROPERTY: 134 Pearson Avenue, Toronto, Ontario

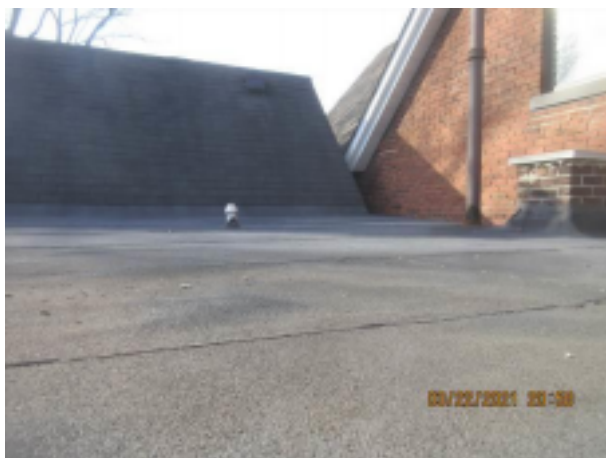
2.03F Modified bitumen membrane roof: This roofing installation typically involves a two-ply application with the seams sealed with either hot tar or heat-sealed with a propane torch. They are a reliable roofing system and typically last in excess of twenty years, depending on the product and the quality of the installation. The modified bitumen roofing membrane above the second floor appears to have been installed upwards of fifteen years ago. The roof surface and installation are in acceptable condition. The flat roofing membrane below the rear second floor deck could not be accessed and its age/condition is unknown. No water stains were observed on the ceiling finishes below.

G: a roof 'tune up' is recommended. The seams on the flat roof should be re-caulked.
