## 11 Laws Street, Toronto, Ontario

## SUMMARY INSPECTION REPORT

## INSPECTION REPORT

PROPERTY: 11 Laws Street, Toronto, Ontario

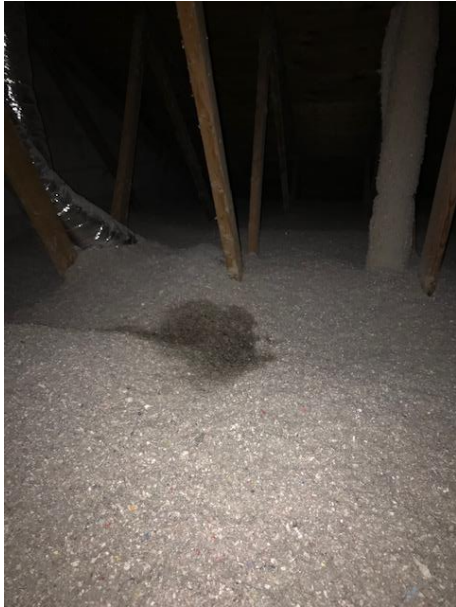
*M: there is moisture on the loose fill insulation below a roof vent (just east of the attic hatch). This likely occurred during the heavy snowfall recently experienced. You may want to have the roof shingles and roof vent in this location inspected by a roofer once the snow is gone. Monitor during normal rainfall to ensure that moisture penetration does not reoccur.*
