SUMMARY INSPECTION REPORT

PROPERTY: 44 Montye Avenue, Toronto, Ontario

Project: 44 Montye Avenue, North York, ON. M6S 2G9

Subject: Foundation Wall Inspection: Structural Report

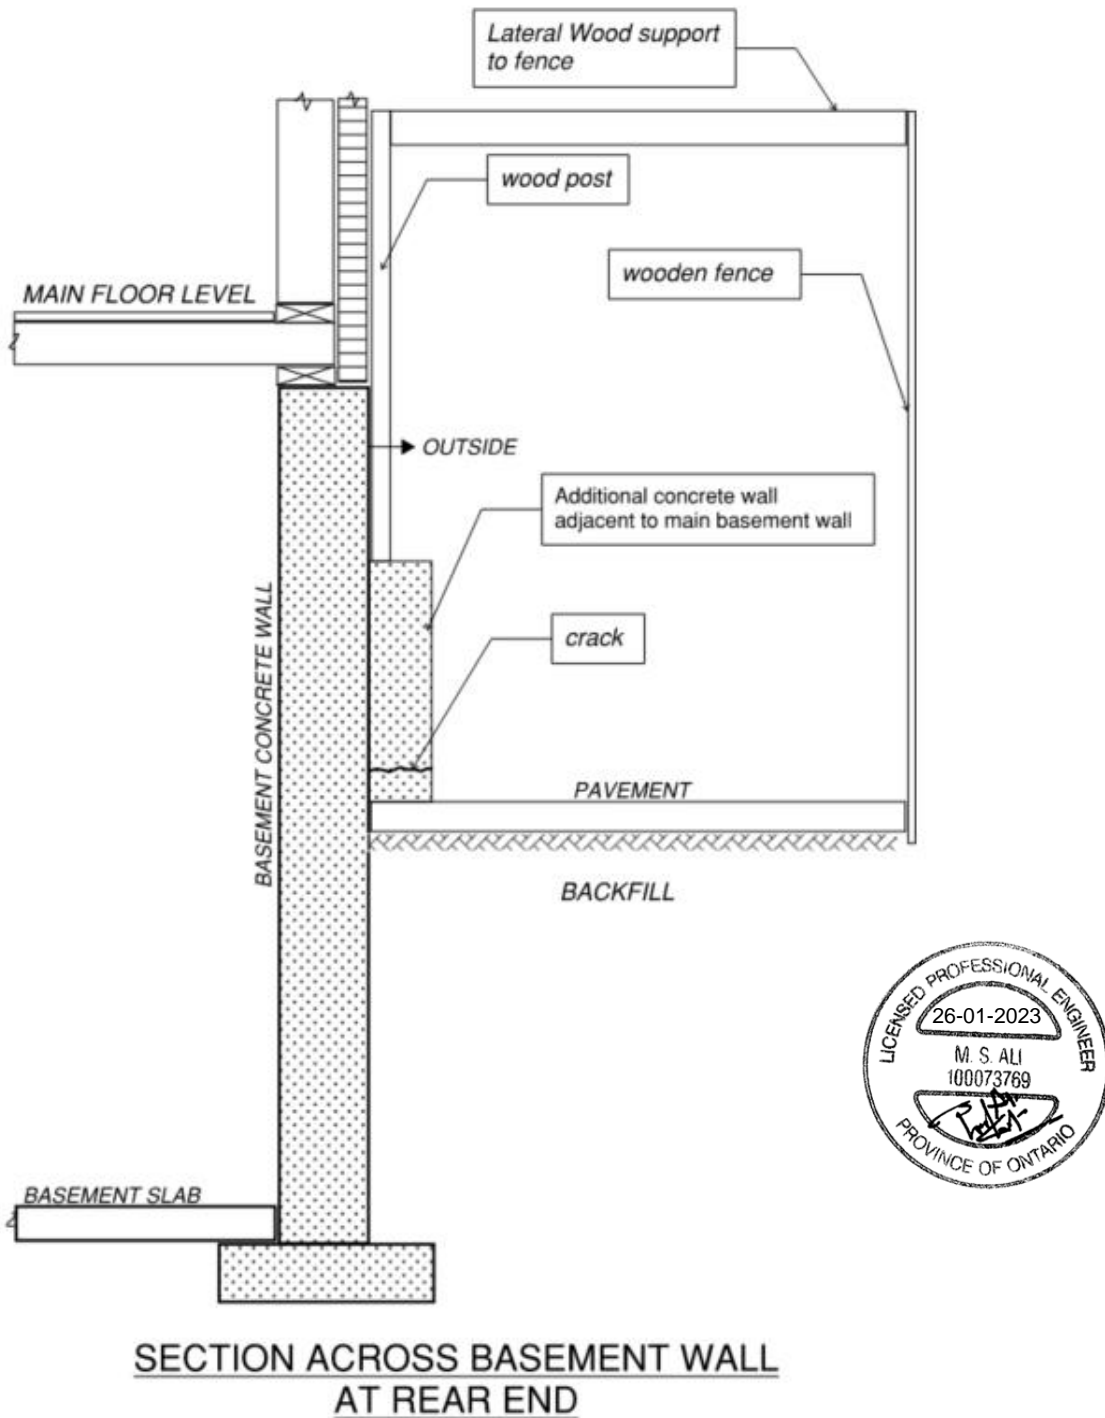
Fig.-01:

Fig.-01 and 02 show the as-built condition of the wall. During inspection, we have noted that original basement wall is structurally sound with no signs of any crack or settlement. From the site condition, we are with the opinion that additional foundation wall protruding out has been constructed adjacent to the main basement wall at later time. Reason of the construction of this wall is unknown.

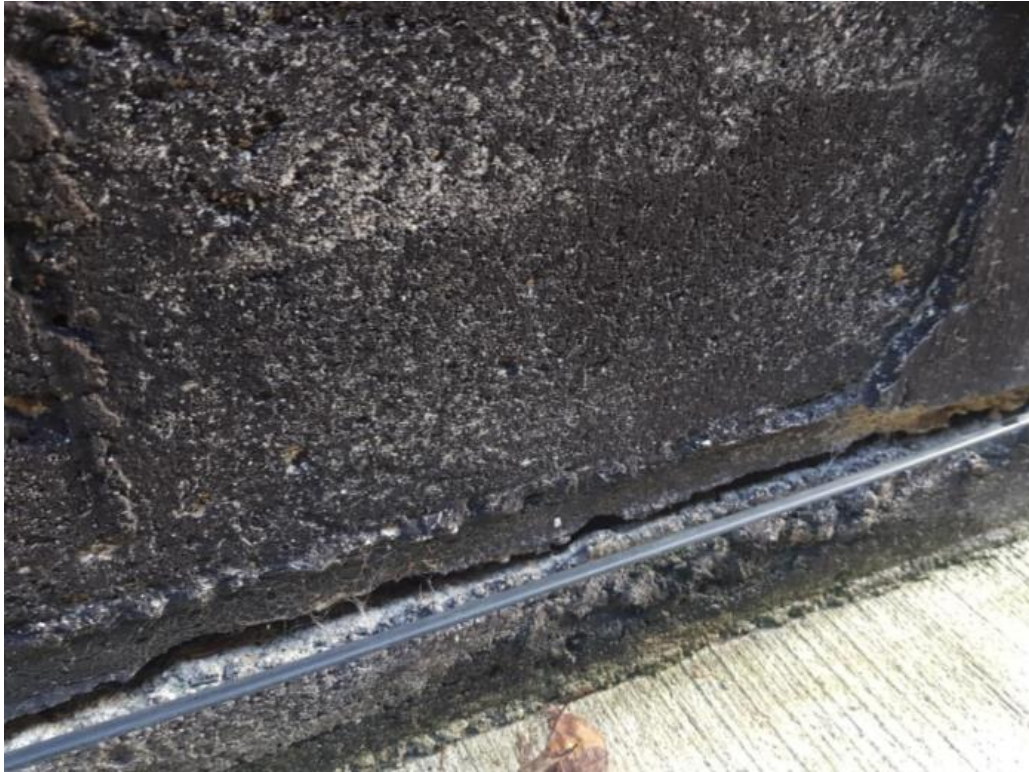
Fig.-03:

Fig.-03 & 04 show the cracks occur in the additional part of the foundation wall. Based on our visual inspection of the wall, we are with the opinion that, wall was constructed over concrete pavement slab with no foundation below.

Fig.-03 & 04 show the cracking of the wall just above the pavement slab. We are with the opinion that this wall is not the part of the main basement wall and is a non-structural wall. The cracks found, do not pose any safety concern to the main structure of the house.

- 1- Settlement of the soil underneath the pavement slab.
- 2- Possible construction joint at the crack location during casting of the foundation wall.
- 3- Foundation wall is not going down 4ft below the grade level and cracks might have caused due to frost related soil movement.

To arrest the crack and to ensure, it does not happen again, the protruding part of the foundation wall shall go down to the main basement wall footing level.

Since, wall is a non-structural wall, alternate solution is to grout the cracks as and when they appear.
