442 St. Johns Road, Toronto, Ontario

SUMMARY INSPECTION REPORT

INSPECTION REPORT

PROPERTY: 442 St. Johns Road, Toronto, Ontario

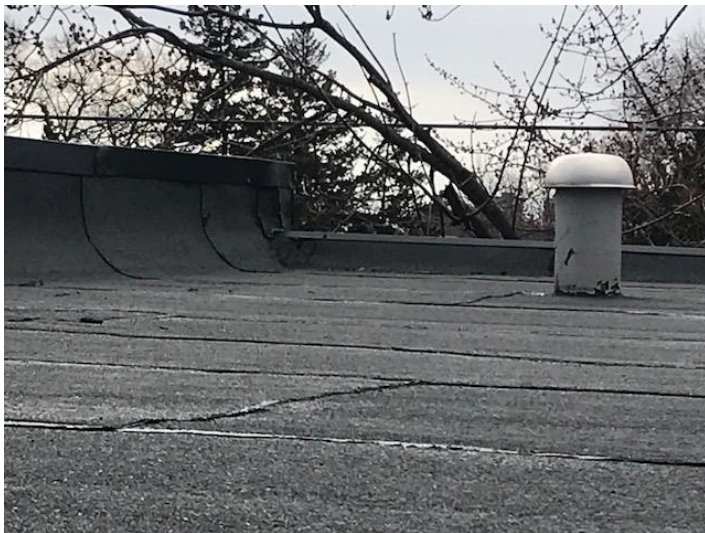
2.03F Modified bitumen membrane roof: This roofing installation typically involves a two-ply application with the seams sealed with either hot tar or heat-sealed with a propane torch. They are reliable roofing system and typically last in excess of twenty years, depending on the product and the quality of the installation. There are modified bitumen roofing membranes covering the flat roofs above the 2nd and 3rd floors. The flat roof about the 3rd floor has been recently resurfaced. Though the flat roof below the 3rd floor deck could not be inspected, it too was recently upgraded according to owner. No water stains were observed on the ceiling finishes below either flat roof.

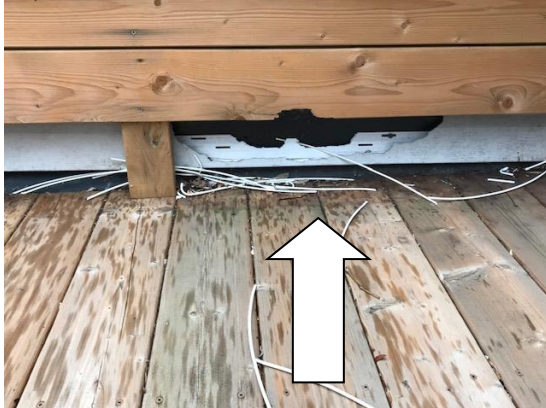
2.09F Vinyl siding: Located on the 3rd floor, this is a durable siding and is relatively maintenance free. The siding is intact. *There is some warping of a few of the vinyl siding panels on the third floor deck, due to heat damage from a BBQ.*

M: there is a section of vinyl siding behind the east wood deck wall on the 3rd floor (at roof level) that is damaged and should be repaired to ensure watertightness.
