454 Runnymede Road, Toronto, Ontario

SUMMARY INSPECTION REPORT

INSPECTION REPORT

PROPERTY: 454 Runnymede Road, Toronto, Ontario

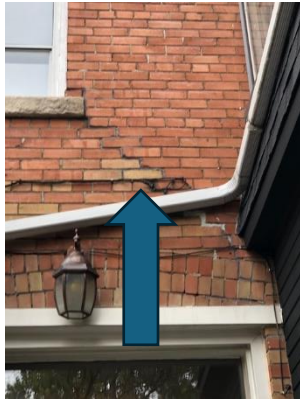
M: there is a diagonal crack in the brickwork above the rear french door set. The brickwork in this location is out of plumb as a result. The crack has been patched with mortar and should be monitored for signs of further movement.

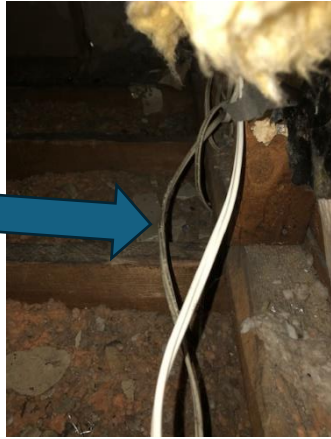
P: a section of wire in the SE knee wall cavity on the 3rd floor is damaged from wildlife activity and should be repaired.
