57 Deforest Road, Toronto, Ontario

SUMMARY INSPECTION REPORT

PROPERTY: 57 Deforest Road, Toronto, Ontario

INSPECTION REPORT

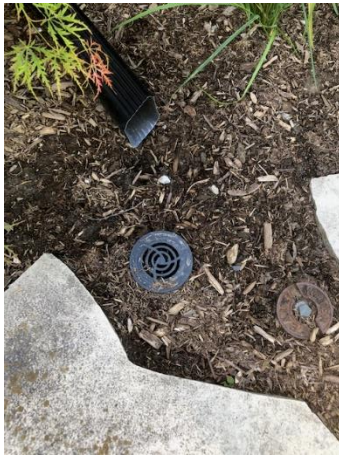
2.01 Surface drainage: The land should show a positive slope away from the house on all sides. This ensures good surface drainage and reduces the possibility of moisture problems in the basement. An area drain is located at the northwest corner of the house. The drain was not tested for water flow. Ensure that it drains freely.
