200 Galley Avenue, Toronto, Ontario

SUMMARY INSPECTION REPORT

INSPECTION REPORT

PROPERTY: 200 Galley Avenue, Toronto, Ontario

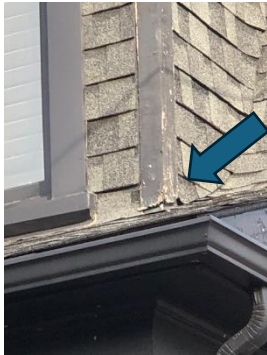
M: monitor deteriorated corner trim beside 2nd floor bedroom window. Maintain with paint.

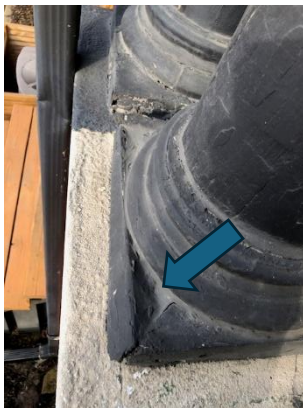
G: the wooden post on top of the west masonry post is out of plumb. As well, the base of the column is rotted. Monitor.

G: the deck structure is somewhat springy and you may want to install a small beam below the deck to provide some rigidity.
