SUMMARY INSPECTION REPORT

PROPERTY: 481 Glenlake Avenue, Toronto, Ontario

INSPECTION REPORT

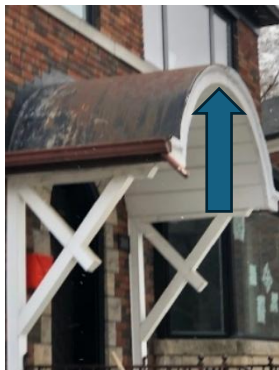
2.03H Sheet metal roofs: The metal roof covering the front porch roof is made of galvanized and is an older installation.

P: the metal trim that covers the front leading edge of this roof structure has pulled away and should be resecured and caulked to ensure a watertight seal and prevent rot to the wood frame behind the trim. As well, the surface of the roof should be sanded and painted with a rust protective paint.

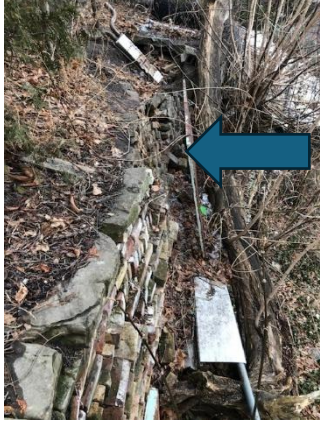
2.12 Retaining walls: The brick retaining wall at the rear of the property was inspected from the top of the wall only. It appears to be for the most part stable.

G: the east end of the wall has failed and should ideally be rebuilt to prevent erosion.

M: monitoring of this wall is recommended.
