# YOUR INSPECTION REPORT

FOR THE PROPERTY AT:  
865 Windermere Avenue  
Toronto, ON M6S 3M8

INSPECTION DATE:  
Thursday, September 25, 2025

RE: Report No. 8595  
865 Windermere Avenue  
Toronto, ON  
M6S 3M8

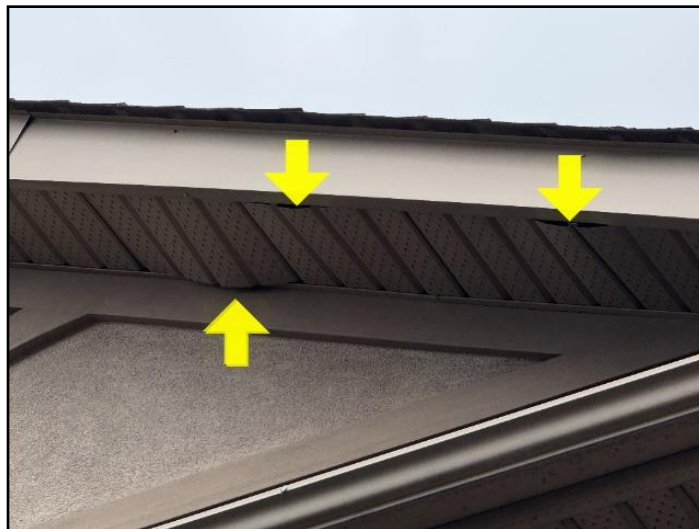
3. Loose or missing pieces

**Condition:** • [Loose or missing pieces](#)

**Task:** Repair

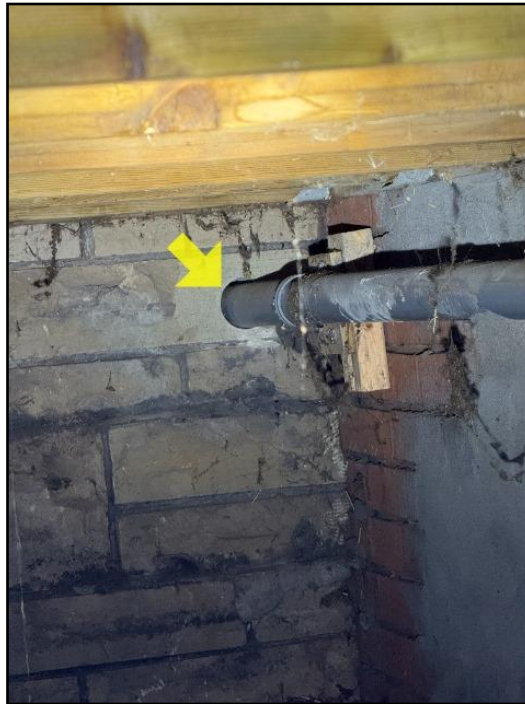
4. one example where conduit enters wall

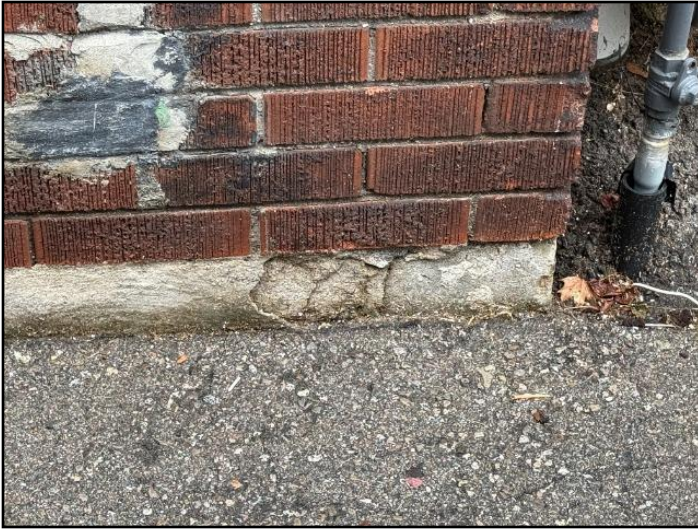
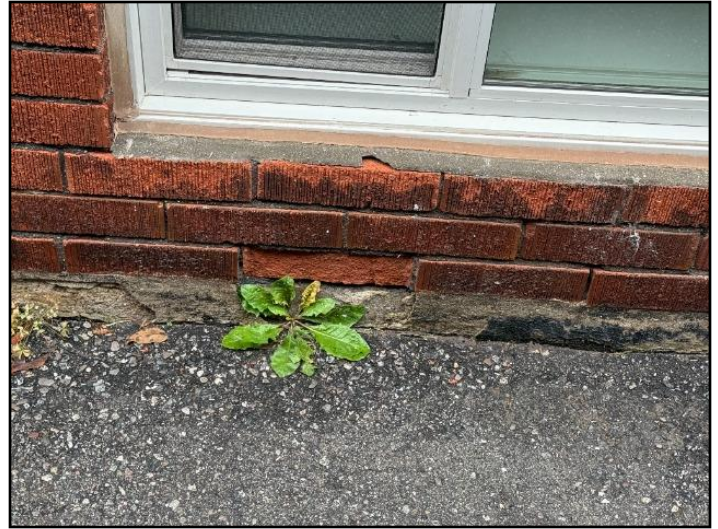
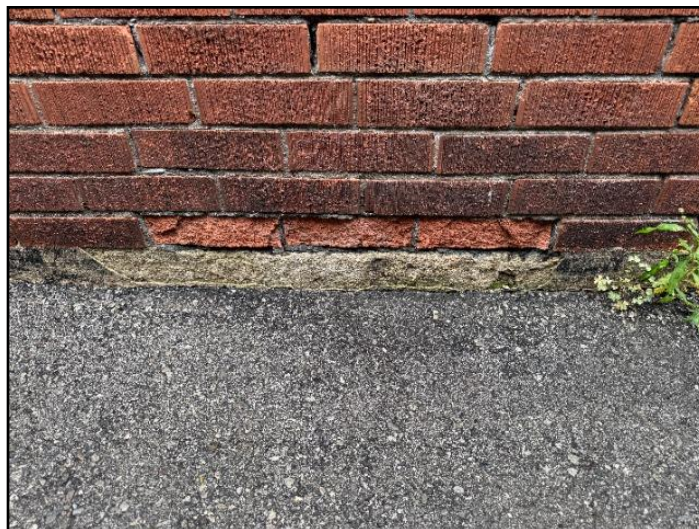
**Condition:** • Masonry and/or mortar deterioration

7. example of typical spalling

Tuckpoint / Repoint mortar and patch/repair spalled masonry. This is typical maintenance for a home of this age. photos show a sampling

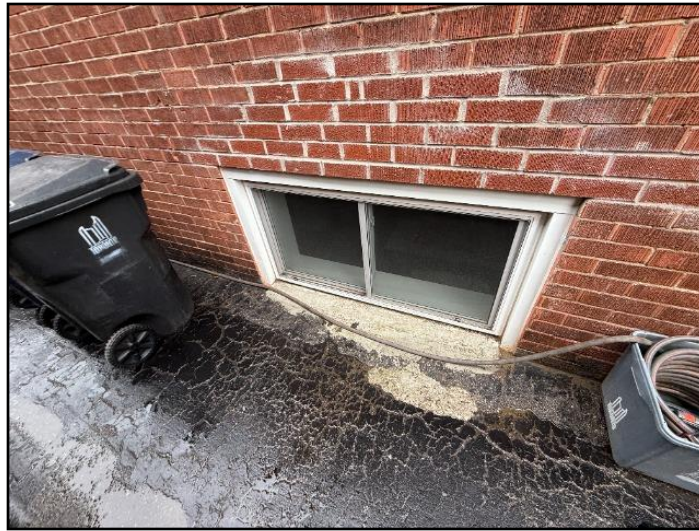
8. Sill - Near or at Grade Level

**Condition:** • Sill - Near or at Grade Level

Basement window at or near grade level. Modern standards recommend that the bottom of the window be at least 6 inches above grade or have a window well installed. Consider adding window well if regrading or when necessary. In the meantime, ensure windows remain well-sealed to prevent water intrusion.

**Task:** Monitor for moisture intrusion / Improve

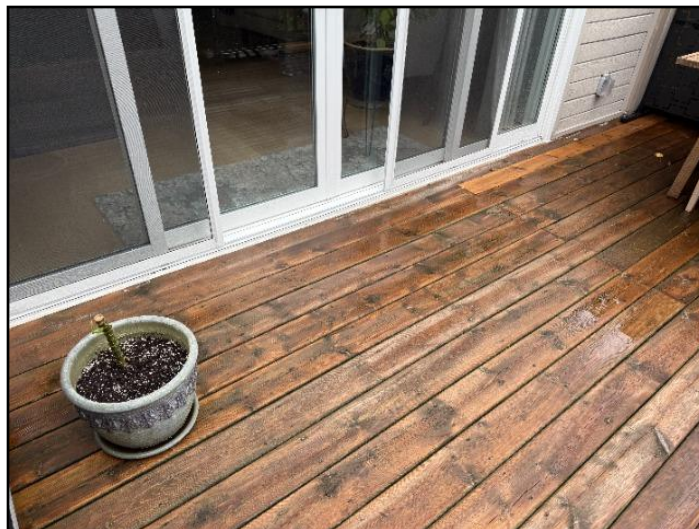
9. Threshold too low

**Condition:** • Threshold too low

Having a minimal step makes the inside/outside transition easier. On the other hand, it also makes it more prone to snow buildup/leakage.

While it is probably not practical to improve the current situation, it will be important to keep any weatherstripping/caulking in good condition.

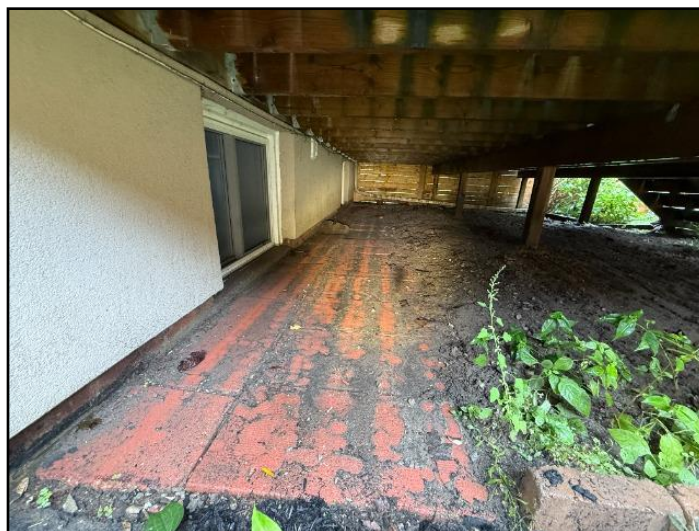
10. Low Areas.

**Condition:** • Low Areas.

Fill in low areas and ensure the ground slopes away from the home for at least 6 feet to promote proper drainage. This is a standard maintenance practice for all homes to prevent water accumulation near the foundation

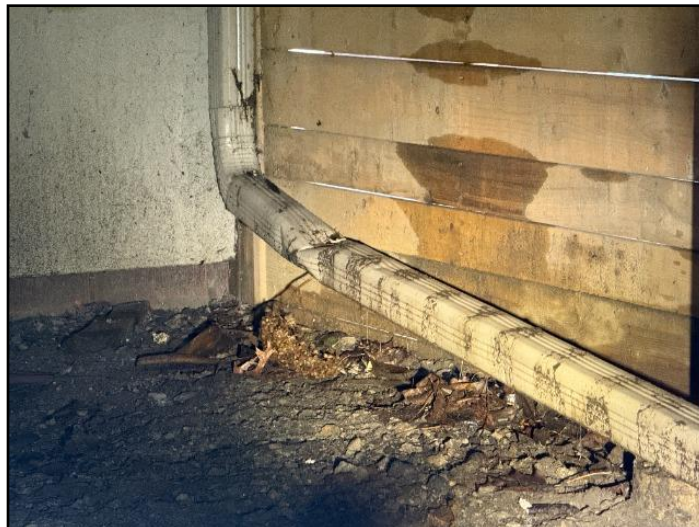
11. Downspout routine maintenance

- Rear screen door sticks - adjust as needed
- Downspout dented/damaged - replace as part of routine maintenance

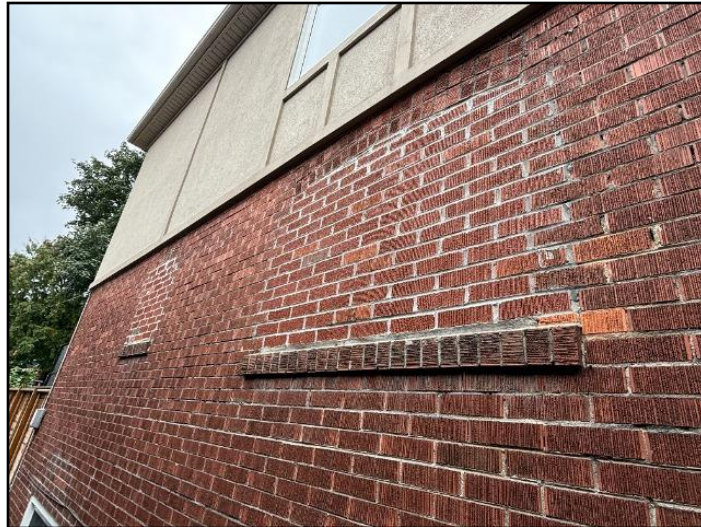
13. one example

**Condition:** • [Prior repairs](#)

It is common to find a multitude of wall repairs on homes of this age (including prior window removals or new door/window installations)

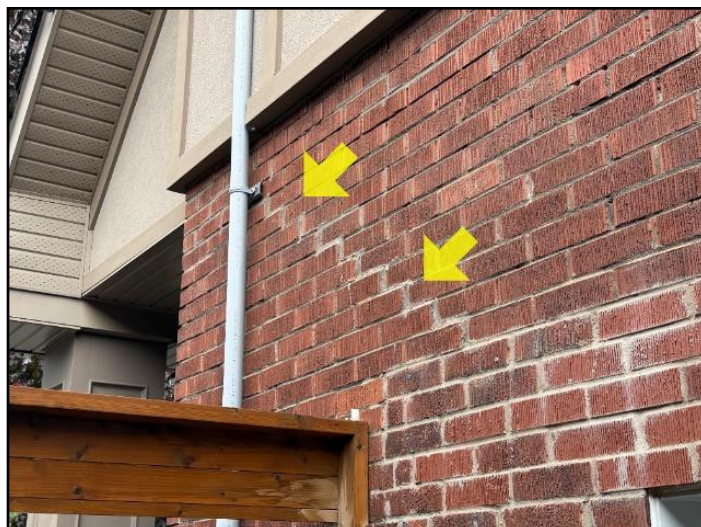
14. right side wall

**Condition:** • [Bowing, leaning or bulging](#)

Prior cracking, displacement, and repairs noted.

The right-side shows prior cracks and displacement. These areas have been previously repaired/patched with no evidence of recent movement.

**Task:** Monitor for movement/cracking

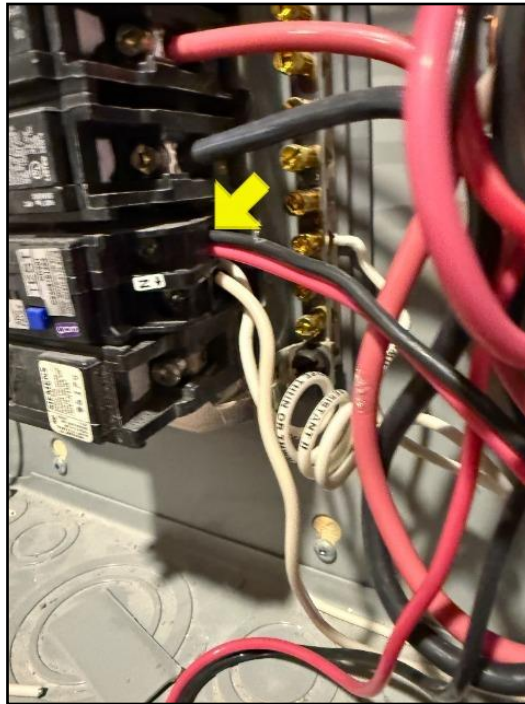
16. Double taps

**Condition:** • [Double taps](#)

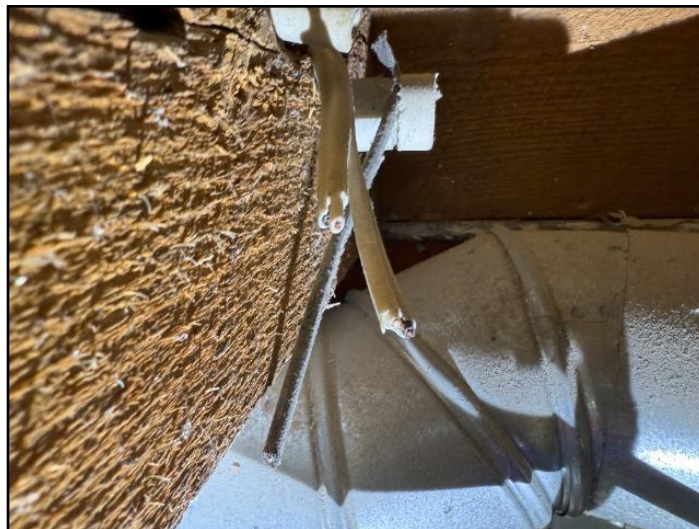
17. example inactive remnants

**Condition:** • [Abandoned wire](#)

Remnants of wiring not in use noted in furnace room. Appear cut and inactive. Removal may be considered

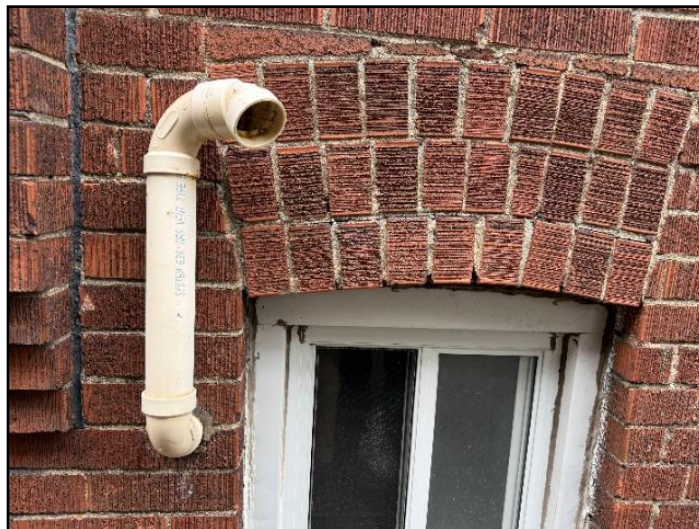
19. Vent termination clearance concern

**Condition:** • Vent termination clearance concern

**Task:** Further evaluation / Correct

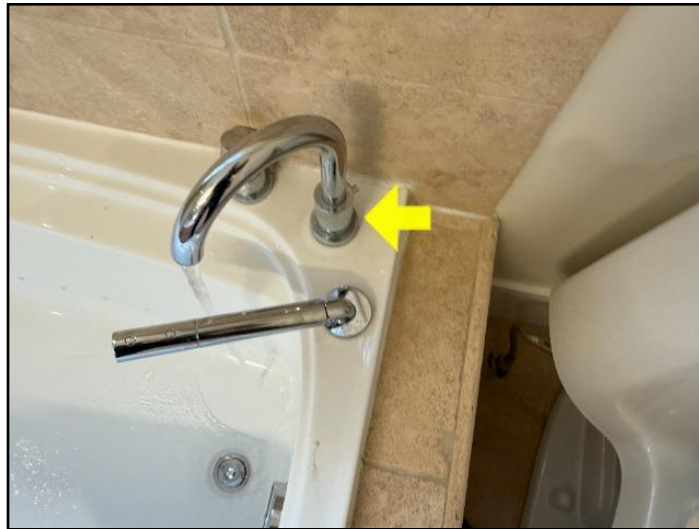
20. Loose

**Condition:** • [Loose](#)

**Task:** Secure
