# YOUR INSPECTION REPORT

FOR THE PROPERTY AT:  
837 Windermere Avenue  
Toronto, ON M6S 3M5

INSPECTION DATE:  
Tuesday, November 4, 2025

RE: Report No. 8760  
837 Windermere Avenue  
Toronto, ON  
M6S 3M5

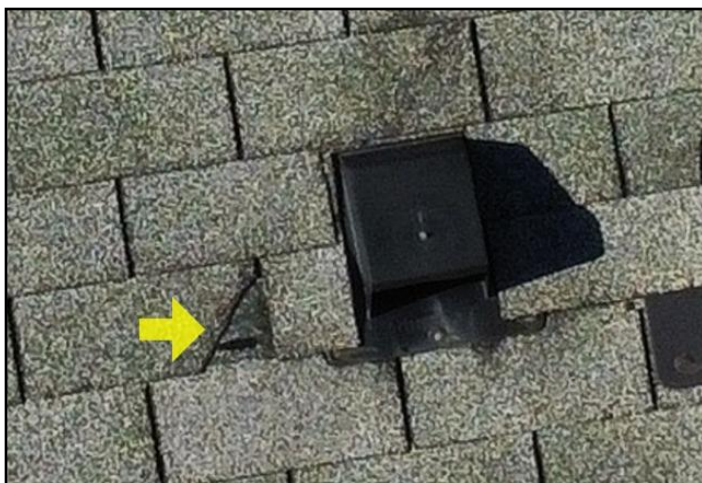
2. Missing, loose or torn

**Condition:** • [Missing, loose or torn](#)

**Task:** Repair

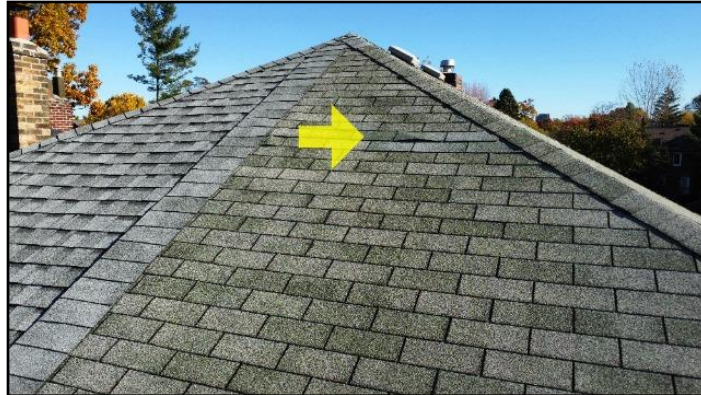
4. Patched example

Condition: • [Patched](#)

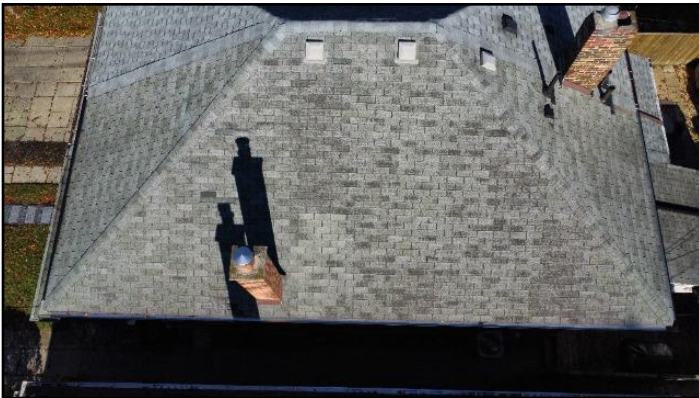
5. Aging

The current roof covering is over 20 years old and shows signs of typical aging, including granule loss, minor cracking, prior patchwork and a few missing shingles. The roof is more worn at the right (south) due to sun exposure.

**Task:** Replace

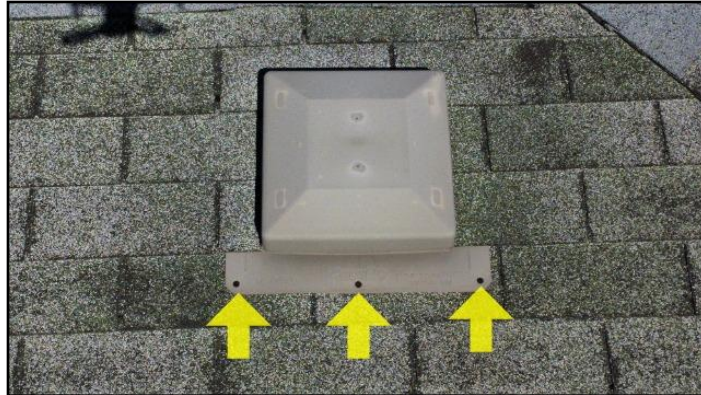
7. Example

**Condition:** • [Exposed fasteners not sealed](#)

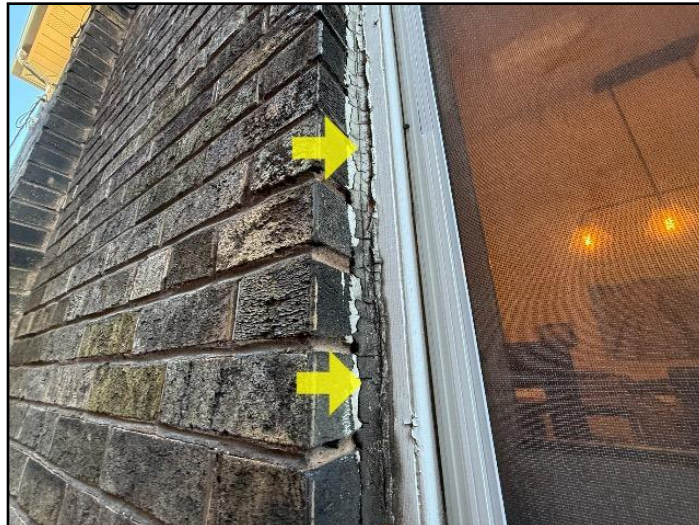
8. example at window

**Condition:** • FOR ALL HOMES - Caulking around windows, doors, and wall penetrations should be inspected regularly and improved as needed to prevent moisture entry and air leakage.

**Task:** Improve

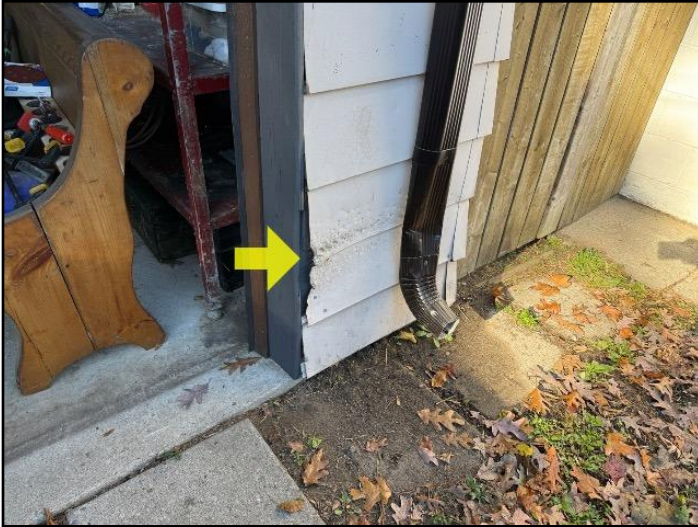
9. Loose example

• Metal siding damaged or missing or loose

**Task:** Repair / Replace

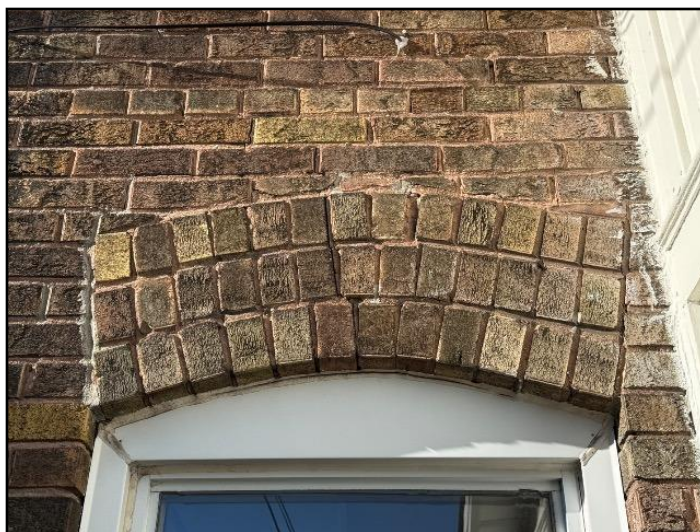
**Condition:** • FOR ALL HOMES - Most masonry walls have small cracks due to shrinkage or minor settlement. These will not be individually noted in the report, unless leakage, building movement or similar problems are noted

12. example of typical cracks at arch

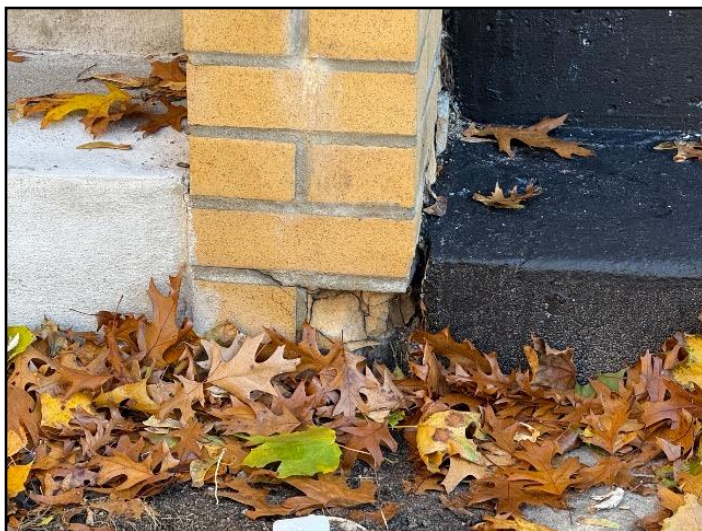
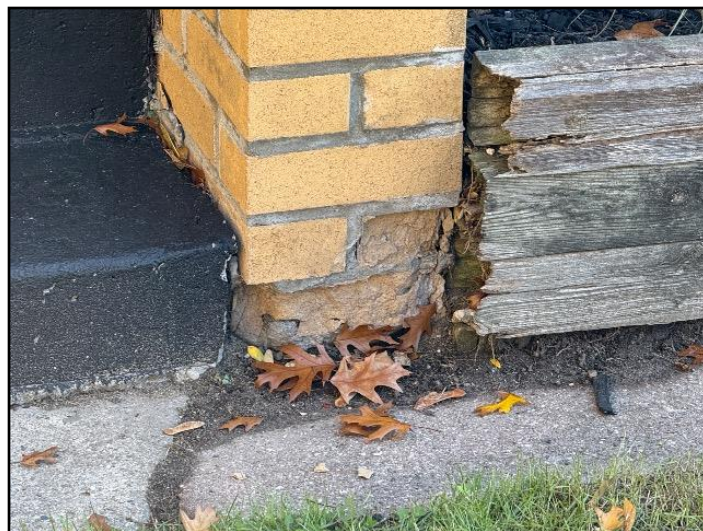
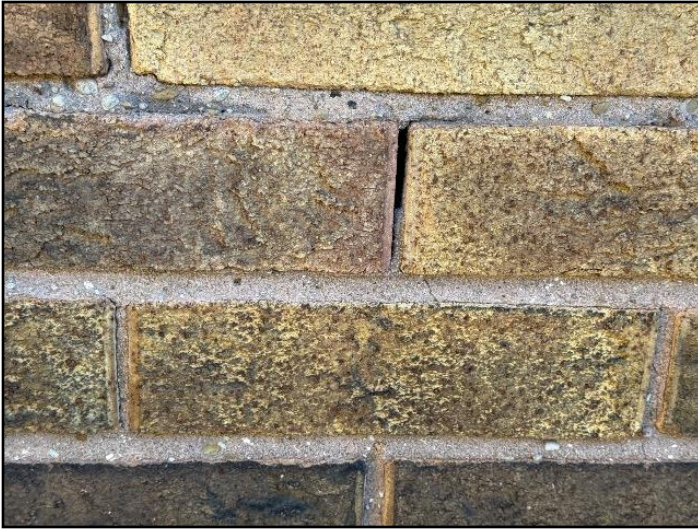
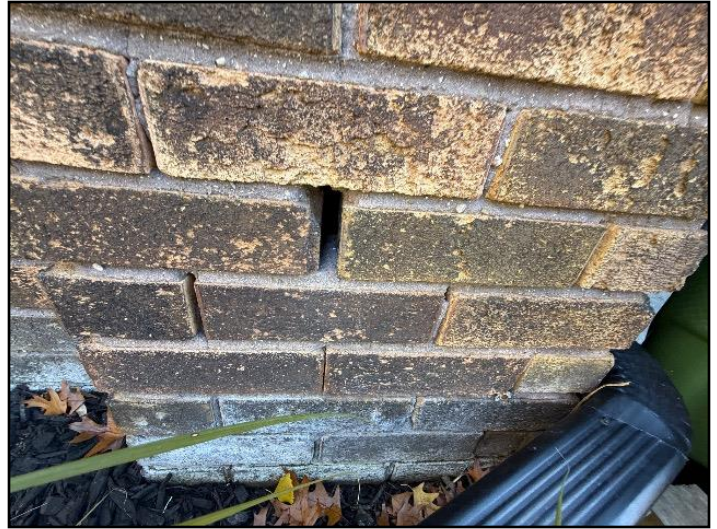
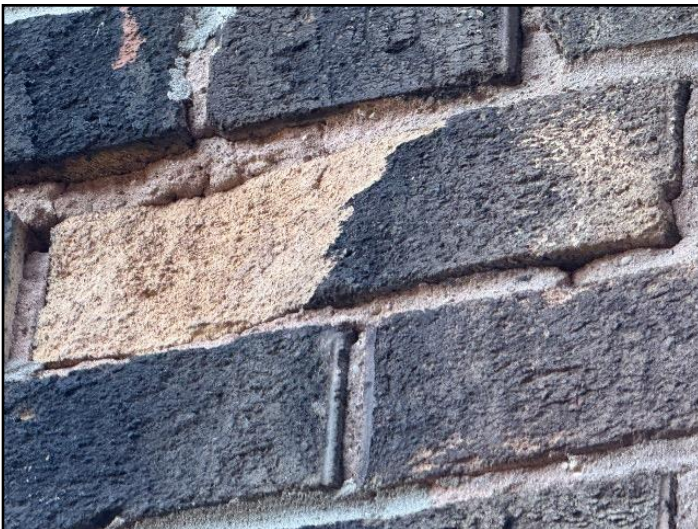
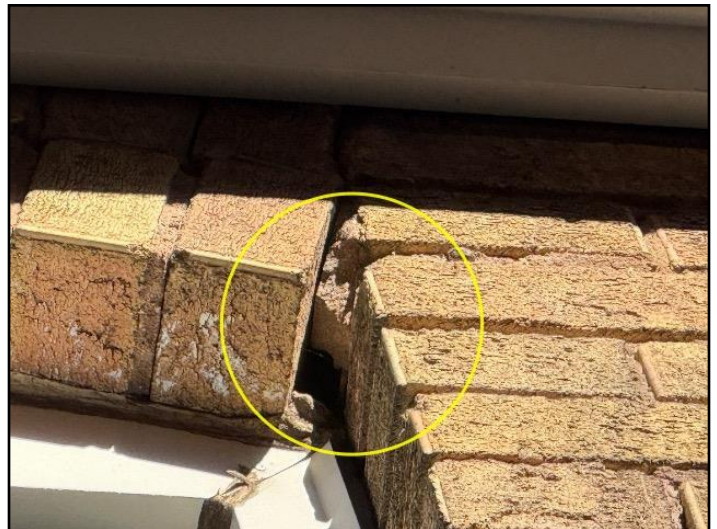
**Condition:** • Masonry and/or mortar deterioration

Tuckpoint / Repoint mortar and patch/repair spalled masonry. This is typical maintenance for a home of this age. photos show a sampling

**Task:** Repair

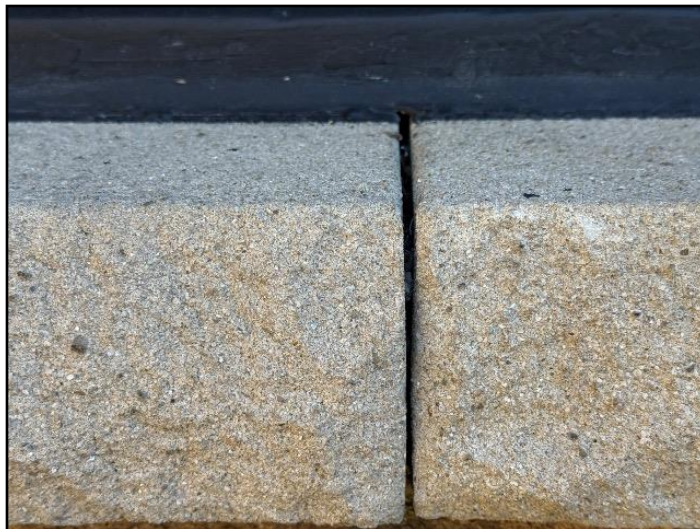
19. example

**Condition:** • Mortar deterioration at window sill control joint

**Task:** Repair

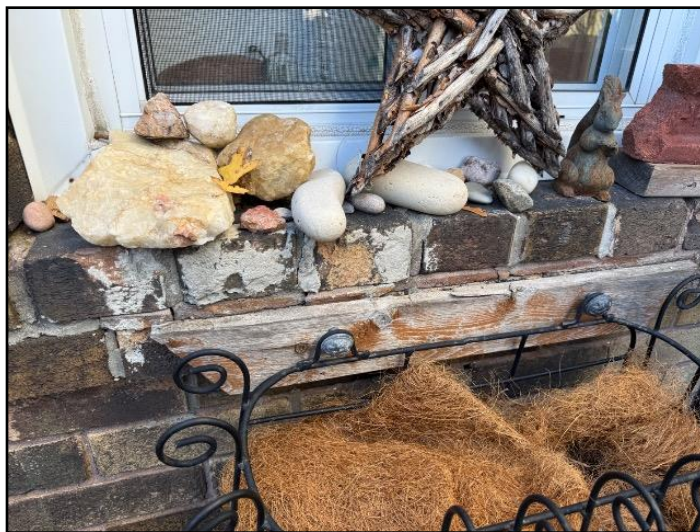
20. Sill deteriorated

**Condition:** • [Sill deteriorated](#)

Masonry deterioration is commonly observed on exterior window brick sills. Brick sills typically deteriorate over time. Consider replacing them with limestone or concrete sills to reduce long-term maintenance requirements.

**Task:** Replace

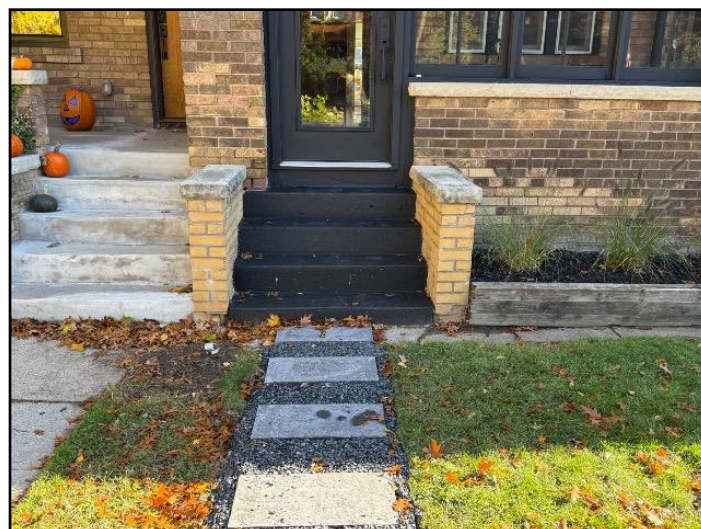
21. Missing

**Condition:** • [Missing](#)

**Implication(s):** Fall hazard

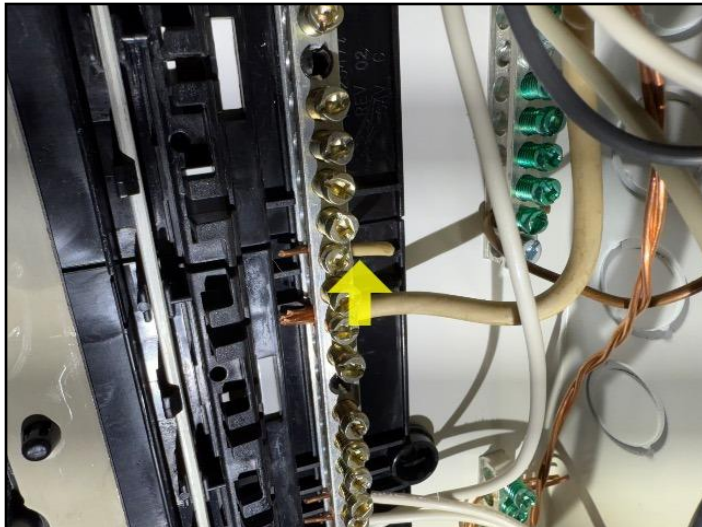
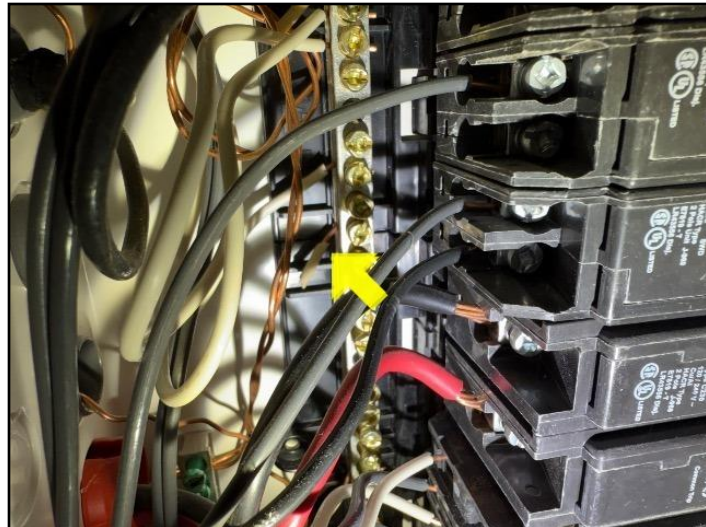
**Condition:** • Inactive/cut conductors noted at neutral bus.

While not hazardous, it should be removed for compliance with standard wiring practices when servicing panel.

**Task:** Remove

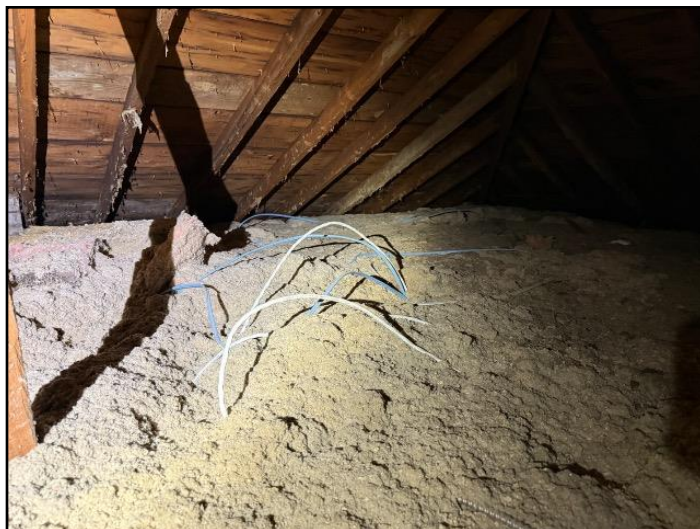
25. Exposed in attics

**Condition:** • [Exposed in attics](#)

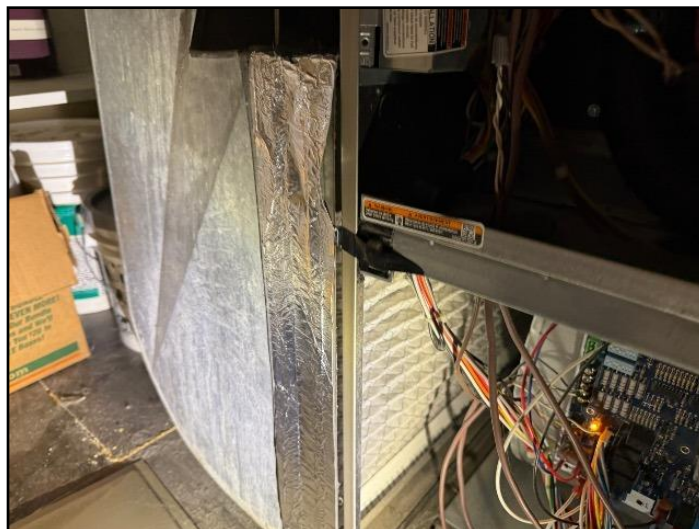
26.

**Condition:** • Poor access to air filter.

**Task:** Install proper sheet metal access panel to allow easy filter replacement and routine servicing.

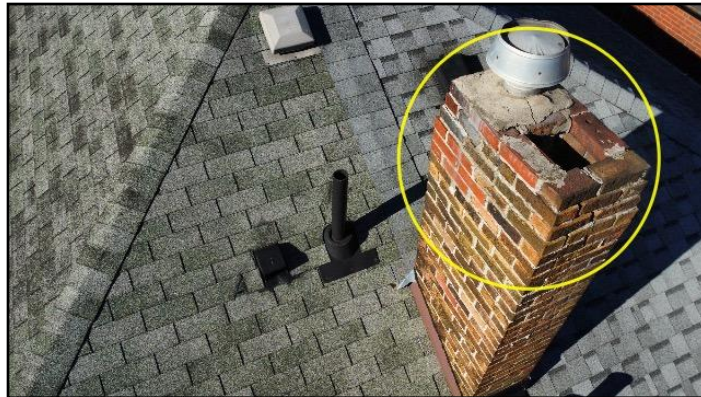
27. Missing

**Condition:** • [Missing](#)

**Implication(s):** Chance of water damage to structure, finishes and contents | Shortened life expectancy of material

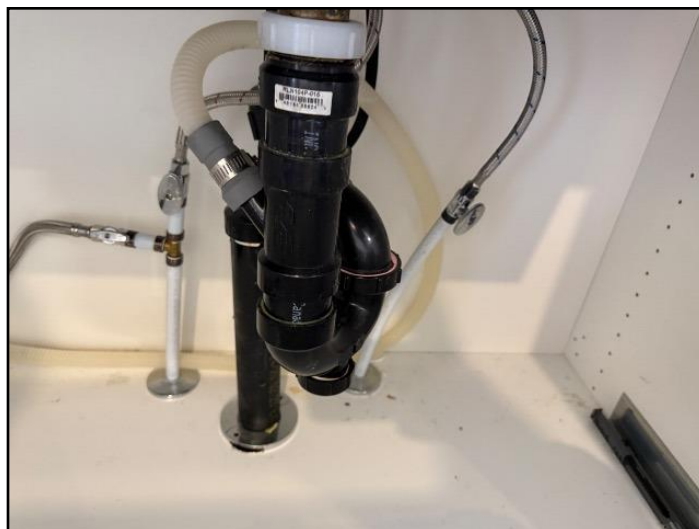
28. Wrong type

**Condition:** • [Wrong type](#)

S-trap configuration may cause siphoning of water from the trap. P-trap preferred

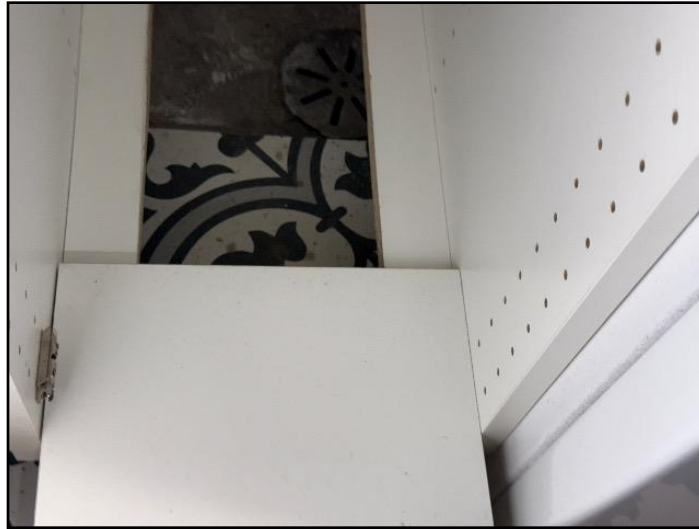
29. Obstructed

**Condition:** • [Obstructed](#)

**Implication(s):** Chance of water damage

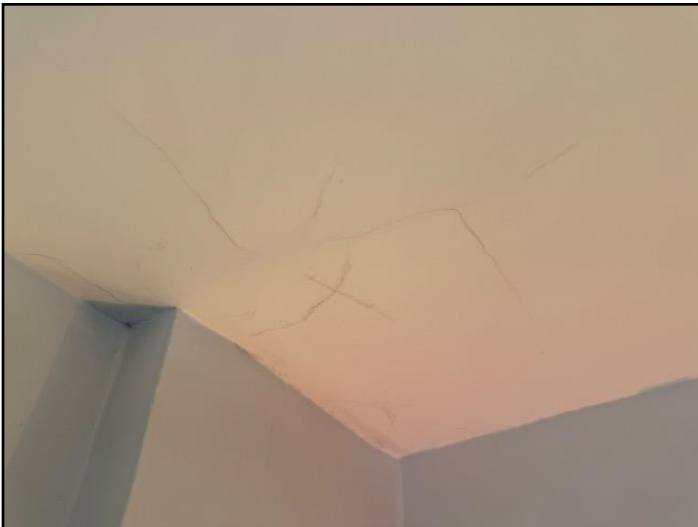
30. example

**Condition:** • Typical minor flaws

All blemishes tested with moisture meter and were dry at time of inspection

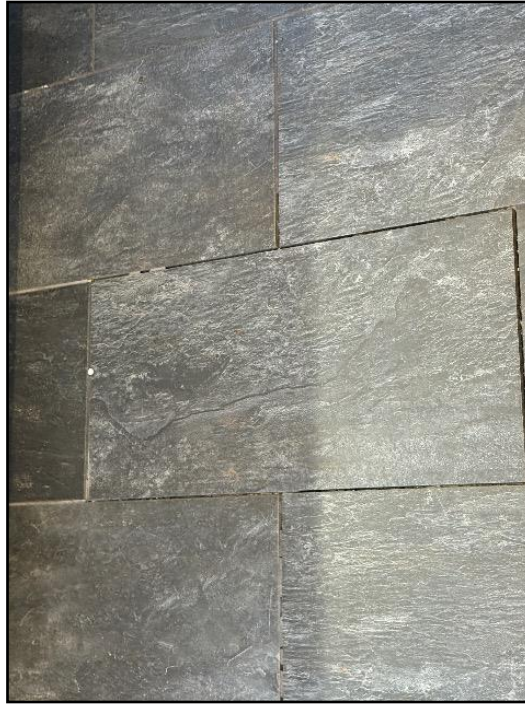
33. one example

**Condition:** • [Grout missing](#)

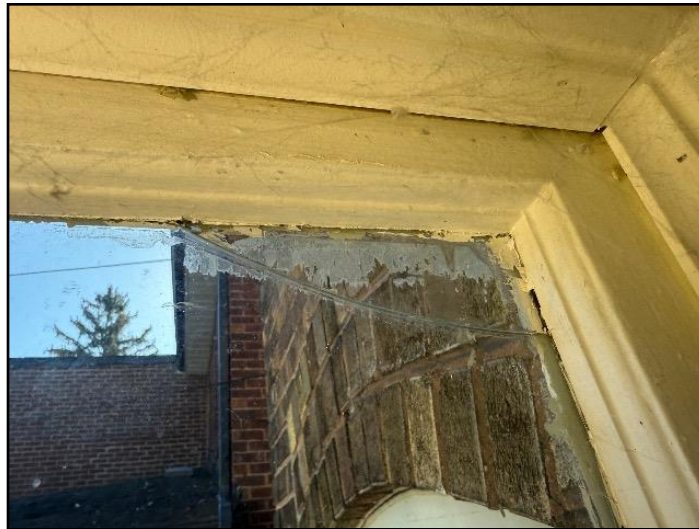
34. Cracked example

**Condition:** • [Cracked](#)

**Task:** Replace

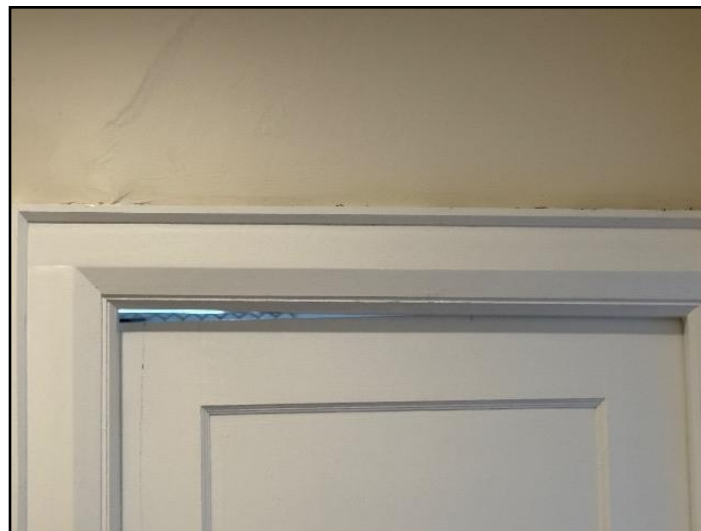
35. example

**Condition:** • [Racked/out-of-square](#)

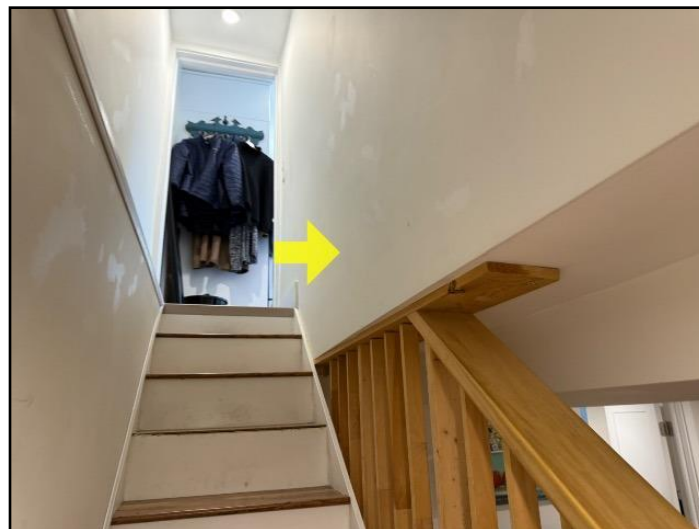
36. Missing

Condition: • [Missing](#)

Implication(s): Fall hazard

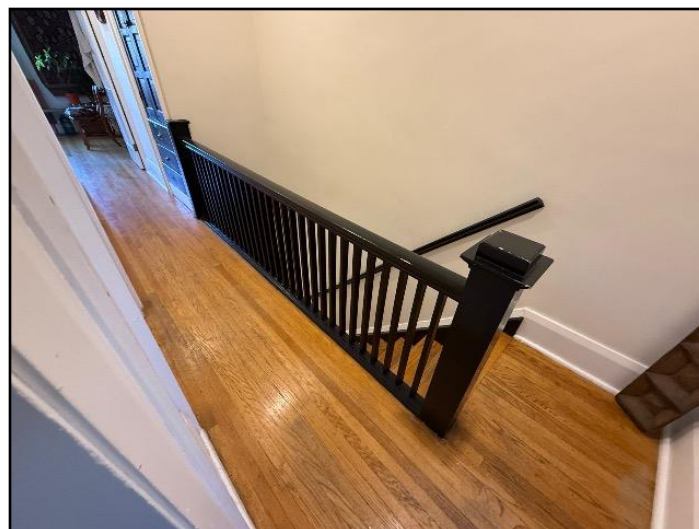
37. Too low

Condition: • [Too low](#)

**Implication(s):** Fall hazard

**Task:** Upgrade
