SUMMARY INSPECTION REPORT

PROPERTY: 138 Lappin Avenue, Toronto, Ontario

INSPECTION REPORT

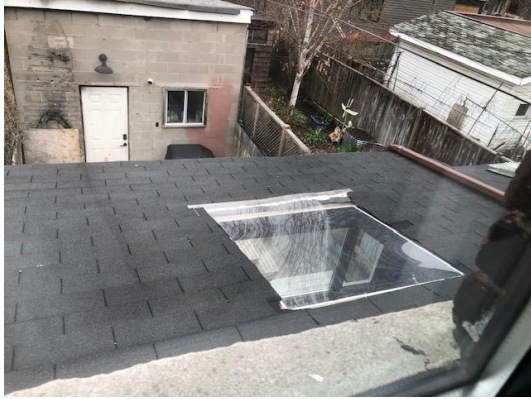
M: the skylight on the rear addition is not a prefabricated unit and is at risk of leaking. A glass panel has been installed and sits below the roof shingles . A piece of acrylic then covers the glass with the asphalt shingles around its perimeter Ideally, a manufactured skylight should be installed with a curb so that is raised off the roof. As a minimum, the roof shingles bordering the acrylic panel should be better sealed with roofing tar.

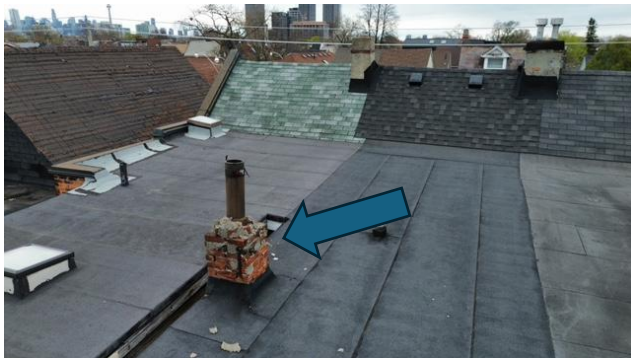
2.07A Brick Chimneys: The chimney at the southwest corner contains two flues for this home. One services the water heater; the other is no longer in use. The brick chimney at the northeast corner is no longer in use. The water heater flue is equipped with a continuous metal liner which is beneficial to prevent deterioration of the chimney and ensure a proper draft in the flue. The chimney at the front has been capped with roofing membrane to prevent water leakage and the brickwork below is parged in a layer of cement. The flashing detail is also flat roofing material.

P: consider removing the unused chimney at the northeast corner to the roof line as it is in poor condition.

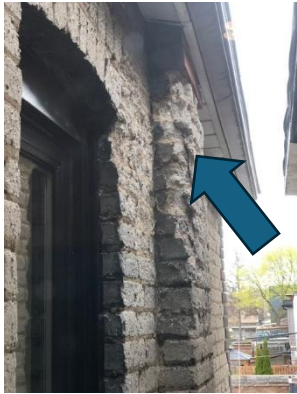
G: the mortar between bricks is loose or missing on the north and east walls and localized tuckpointing repairs are recommended. The severely deteriorated brick below the unused chimney on the east wall at the rear should be patched with cement. Further decay will not occur if the chimney above is dismantled and sealed.
