# Your Inspection Report

130 West Lodge Avenue  
Toronto, ON M6K 2T5

Friday, September 25, 2026

RE: Report No. 9840  
130 West Lodge Avenue  
Toronto, ON  
M6K 2T5

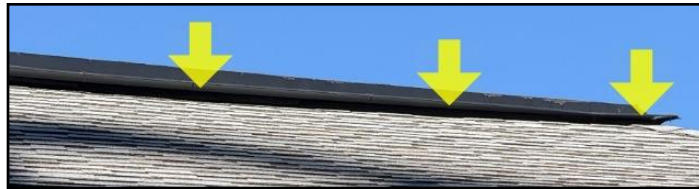
4.

**Condition:** • Lifted flashing

**Time:** Less than 1 year or next annual roof inspection

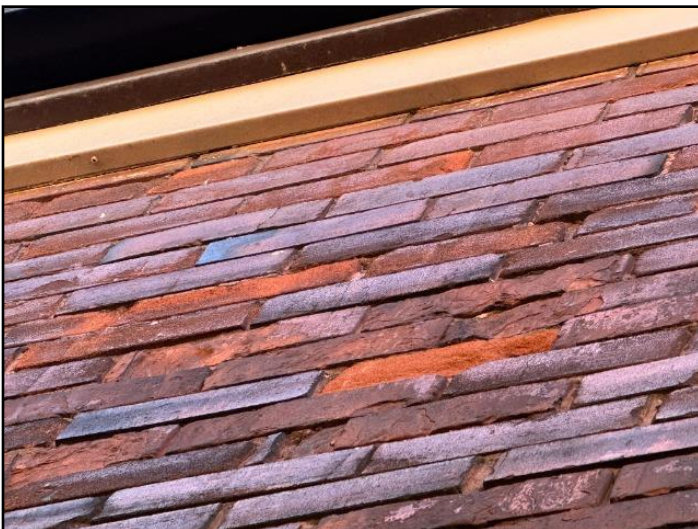
**Condition:** • Masonry and/or mortar deterioration

Localized mortar deterioration, open joints, minor cracks and brick spalling remain at various exterior masonry areas as is common for homes of this age.

5. Minor spalling example

**Task:** Repair

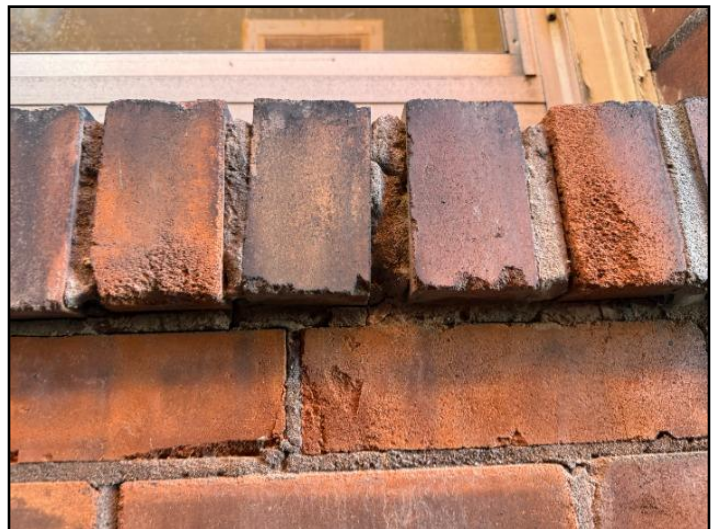
6. Typical mortar deterioration at brick sill

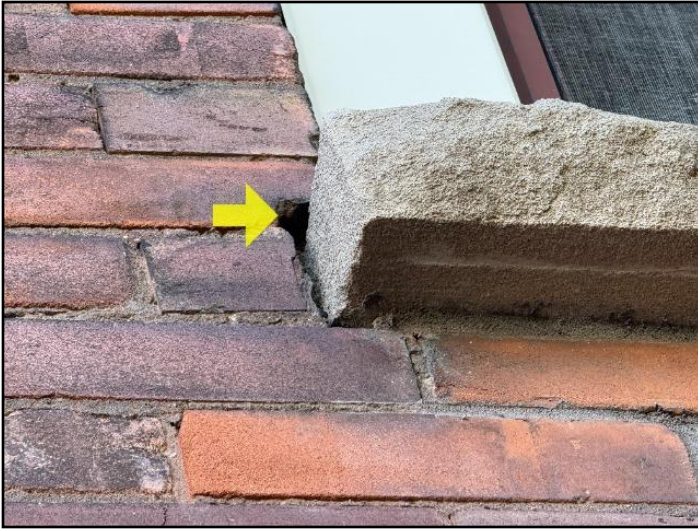
7. Missing mortar example

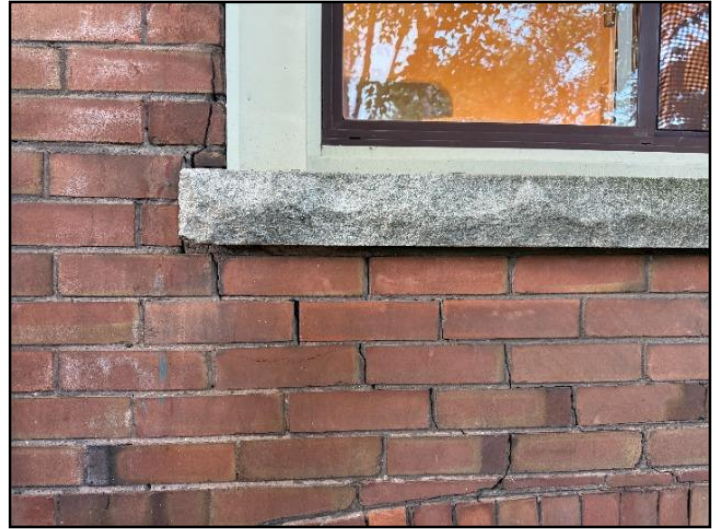
8. Typical minor cracks at front

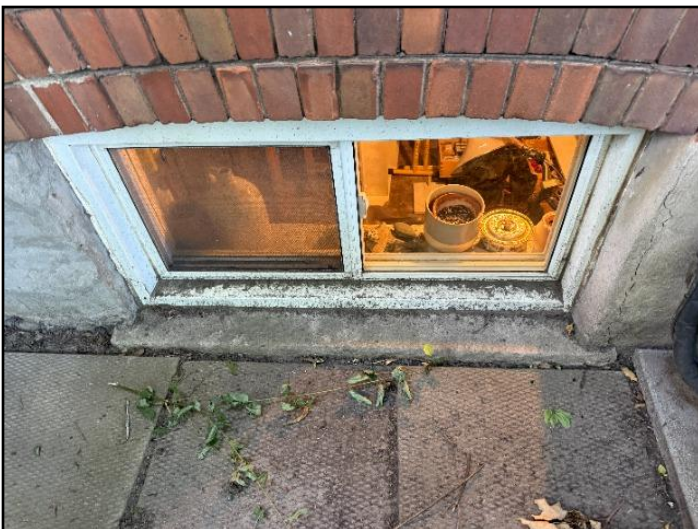
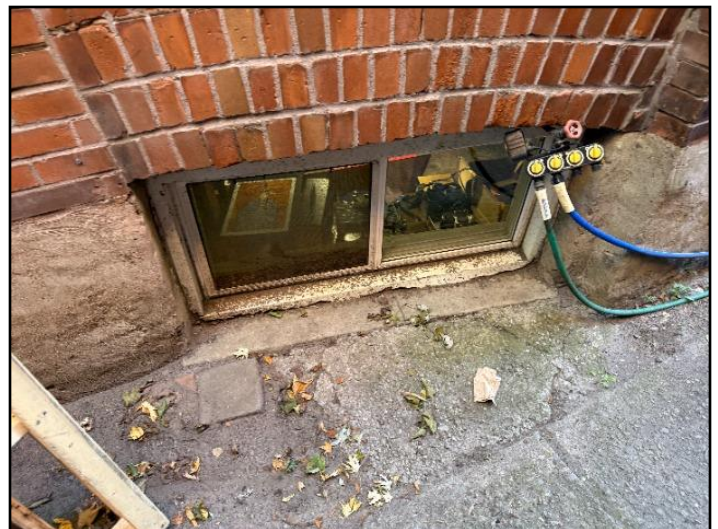
9. example

**Condition:** • Sill - Near or at Grade Level

Basement window at or near grade level. Modern standards recommend that the bottom of the window be at least 6 inches above grade or have a window well installed. Consider adding window well if regrading or when necessary. In the meantime, ensure windows remain well-sealed to prevent water intrusion.

**Task:** Monitor for moisture intrusion / Improve

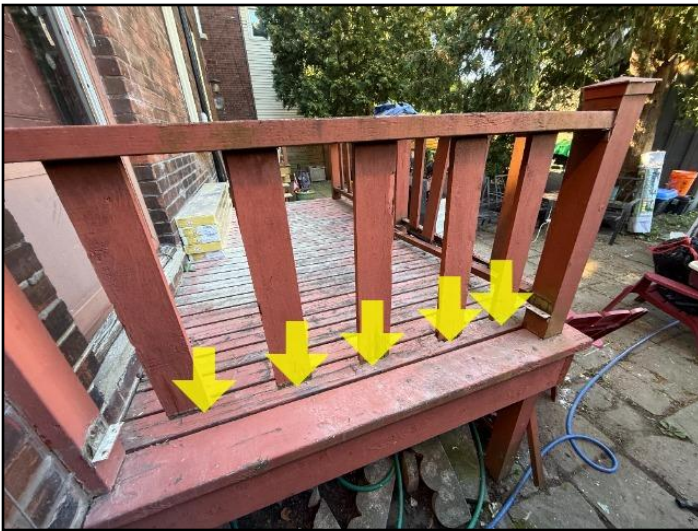
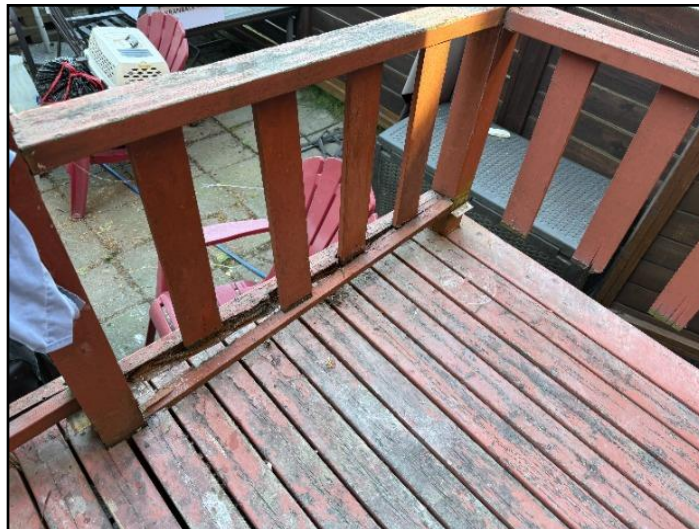
**Condition:** • Spindles loose or damaged

Guard spindles and lower framing were loose/deteriorated. Some deck/stair boards were also loose or not well secured, and deck surfaces were weathered.

11. Spindles loose or damaged

13. Spindles loose or damaged

**Task:** Repair / Replace

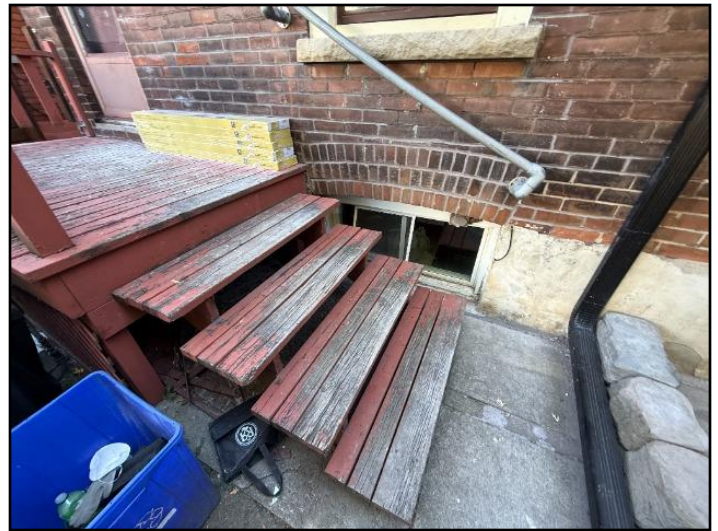
12. Wood step board not secured

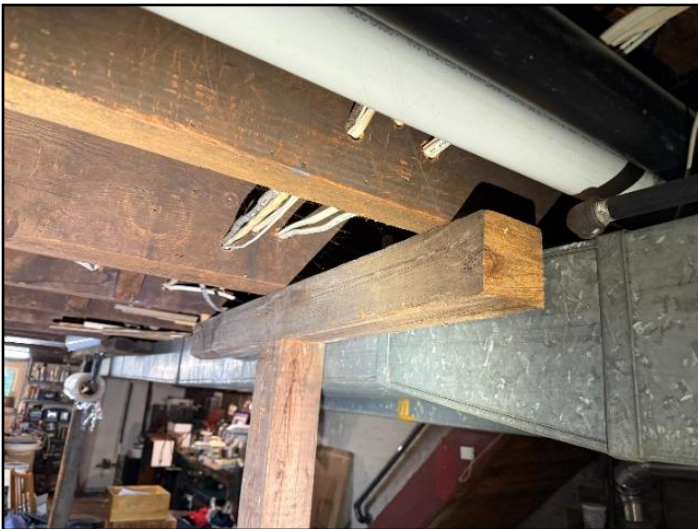
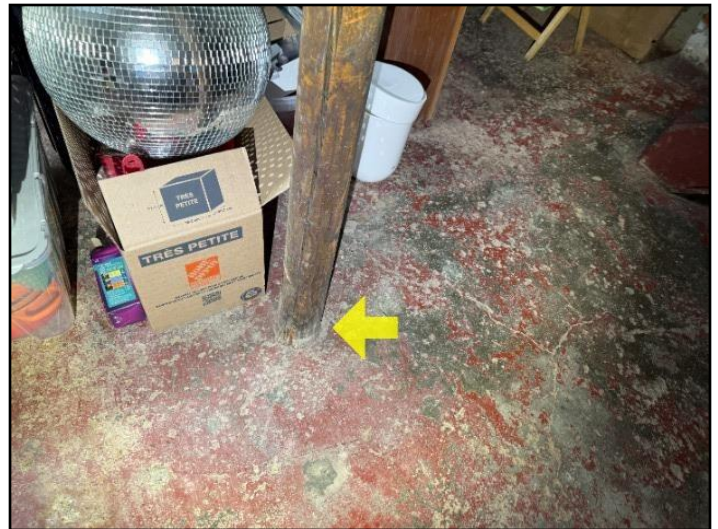
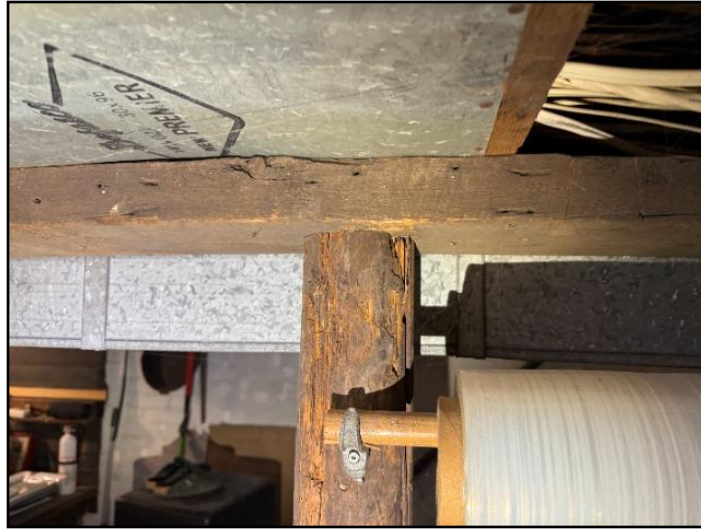
**Condition:** • Unconventional support arrangement

This is a century-plus home with original and altered structural components. Localized added wood posts, blocking and other support arrangements were noted in the basement. These types of alterations are common in homes of this age. Visible areas appeared to be performing at the time of inspection; however, the adequacy of these support arrangements is beyond the scope of a home inspection. One wood post was not secured at the base.

**Task:** Have qualified contractor review and improve / secure as needed

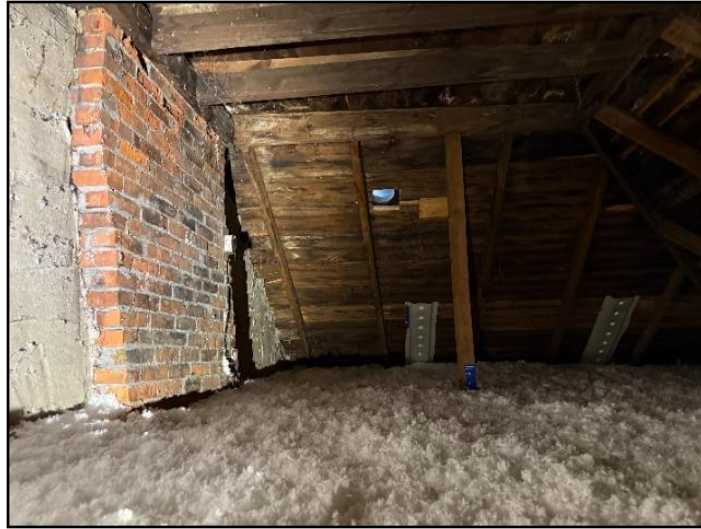
**Condition:** • Water stains or discoloration - Attic plank boards

Discoloration or water staining was noted on the plank board sheathing in the attic. This is a common observation in older homes and is typically the result of historical moisture exposure, condensation, natural aging and weathering of the wood. Some darkened areas may also be associated with fungal staining; however, confirming the exact nature of the discoloration is beyond the scope of a home inspection.

17. Water stains or discoloration - Attic plank...

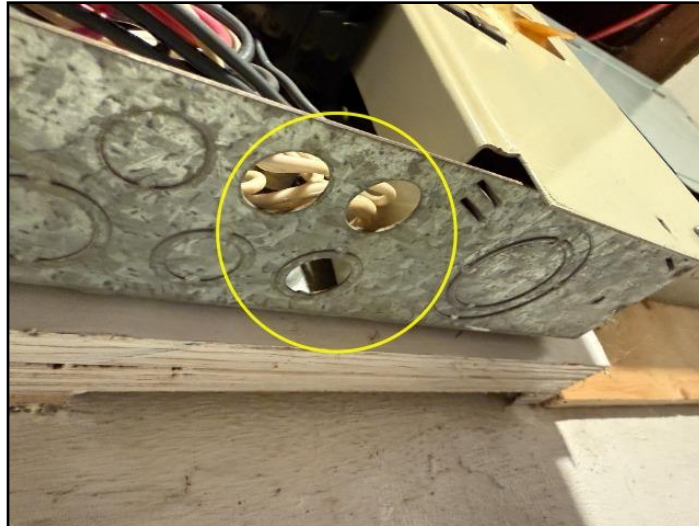
**Condition:** • [Openings in panel](#)

19. Openings in panel

**Time:** As Soon As Possible

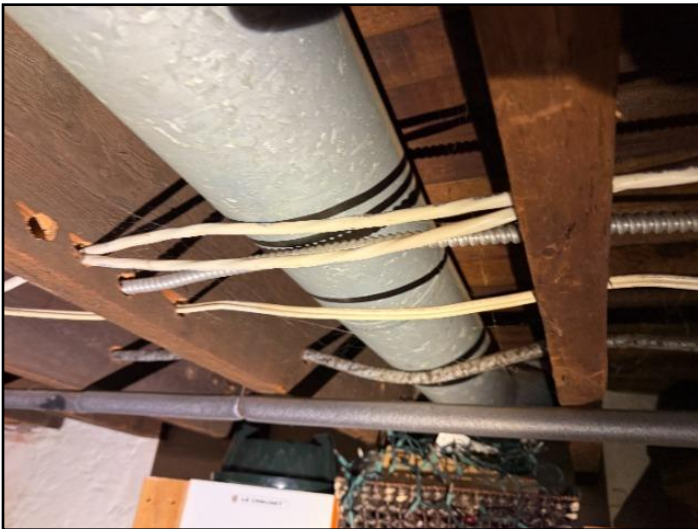
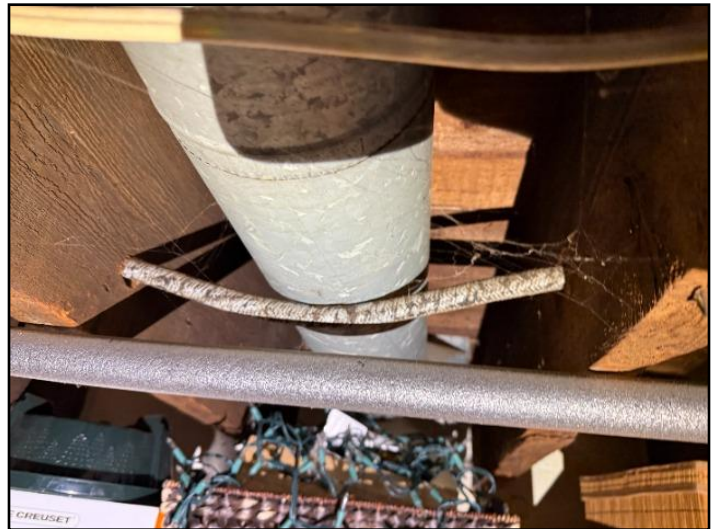
**Condition:** • [Too close to/touching duct, pipe, vent or chimney](#)

20. Too close to/touching duct, pipe, vent or...

21. Too close to/touching duct, pipe, vent or...

**Time:** As Soon As Possible

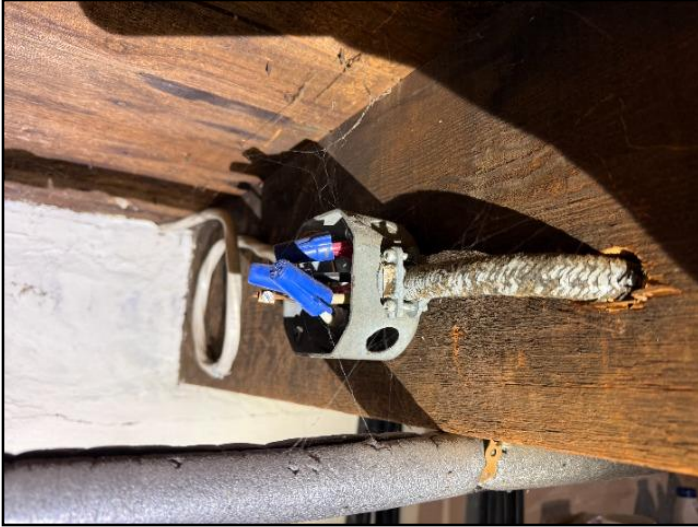
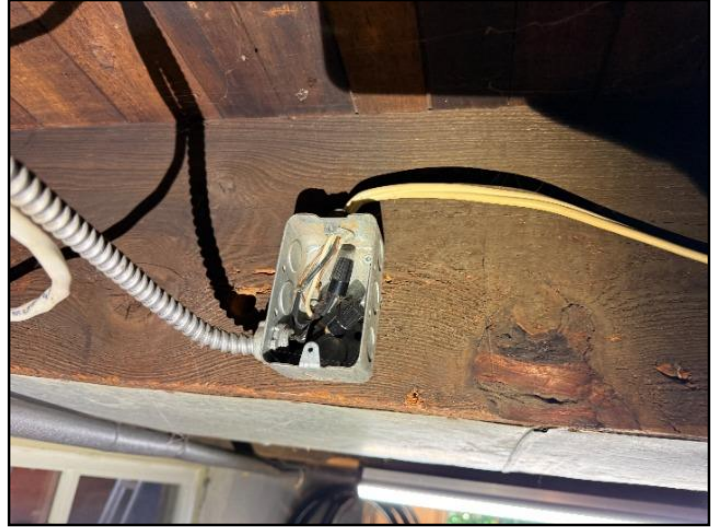
**Condition:** • Cover missing

**Location:** Various basement

**22.** Cover missing

**23.** Cover missing**DISTRIBUTION SYSTEM \ Outlets (receptacles)****Condition:** • [GFCI/GFI needed \(Ground Fault Circuit Interrupter\)](#)

**Task:** Provide Covers**Time:** As Soon As Possible**Cost:** Minor

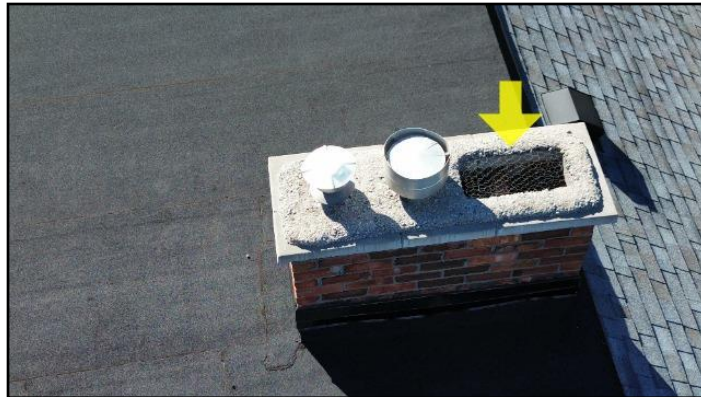
Condition: • [Rain cap missing or damaged](#)

**24.** *Rain cap missing or damaged*

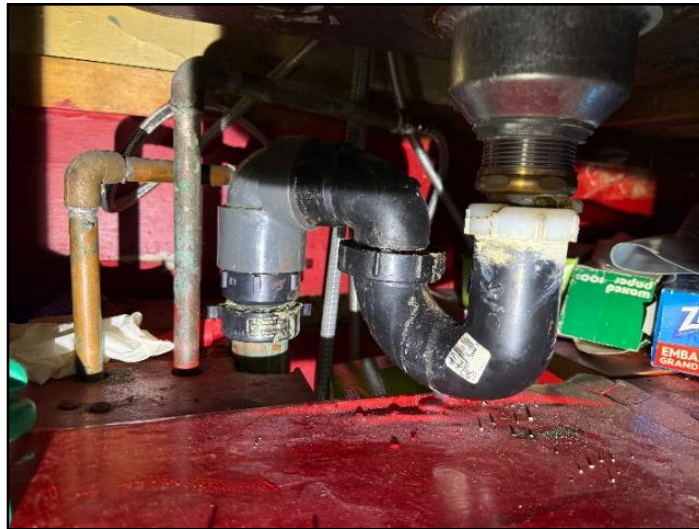
**Condition:** • [Wrong type](#)

Trap arrangement appears to form an S-trap, with the drain piping turning downward after the trap. Connections are also older/irregular. Minor water droplets were noted below the sink; the source could not be confirmed and no dripping was observed during testing.

27. Wrong type

**Task:** Monitor for siphoning, slow draining, sewer odours or leakage / Repair if necessary

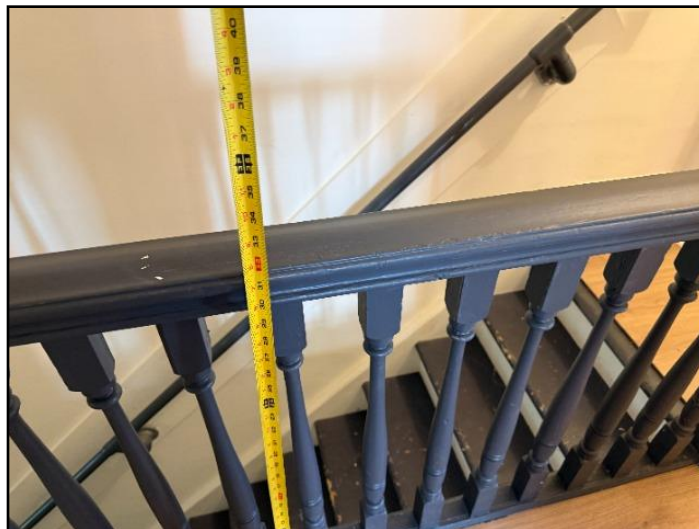
**Condition:** • [Too low](#)

28. Too low

**Task:** Upgrade

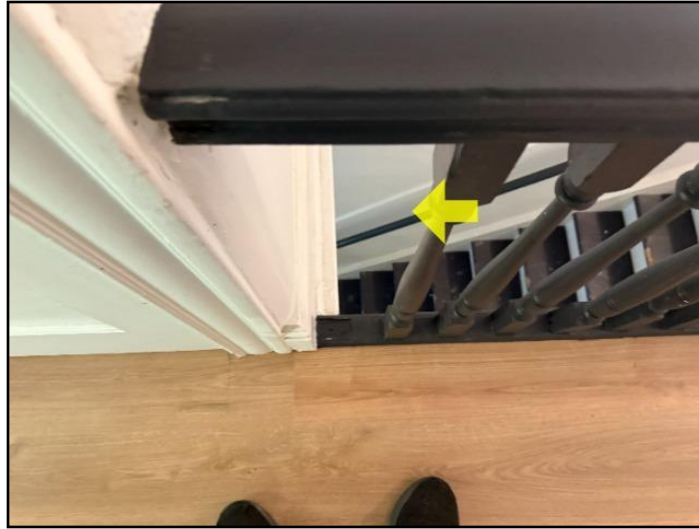
**Condition:** • [Too far apart](#)

29. Too far apart
