525 Indian Road, Toronto, Ontario

SUMMARY INSPECTION REPORT

INSPECTION REPORT

PROPERTY: 525 Indian Road, Toronto, Ontario

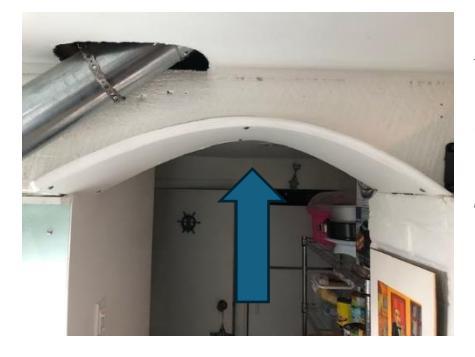
1.04 Interior framing: All visible joists are sound and properly spaced. The joists in the basement are composed of 2" by 8" lumber. Floors felt solid throughout. The built-up wood beam in the basement provides intermediate support for the floors and walls above.

M: the wood beam in the basement has been significantly cut to enable better headroom into the bathroom and furnace room area. It is not known whether the beam has been re-supported in the adjacent wall cavity, though there is no evidence of settlement or cracking in the beam where the cut was made.
